**SPCC Inspection Photograph Log**

**Jackson and Son Oil**

**84721 Happel Lane, Seaside, OR 97138**

**Inspection and Photograph Date: September 21, 2021**

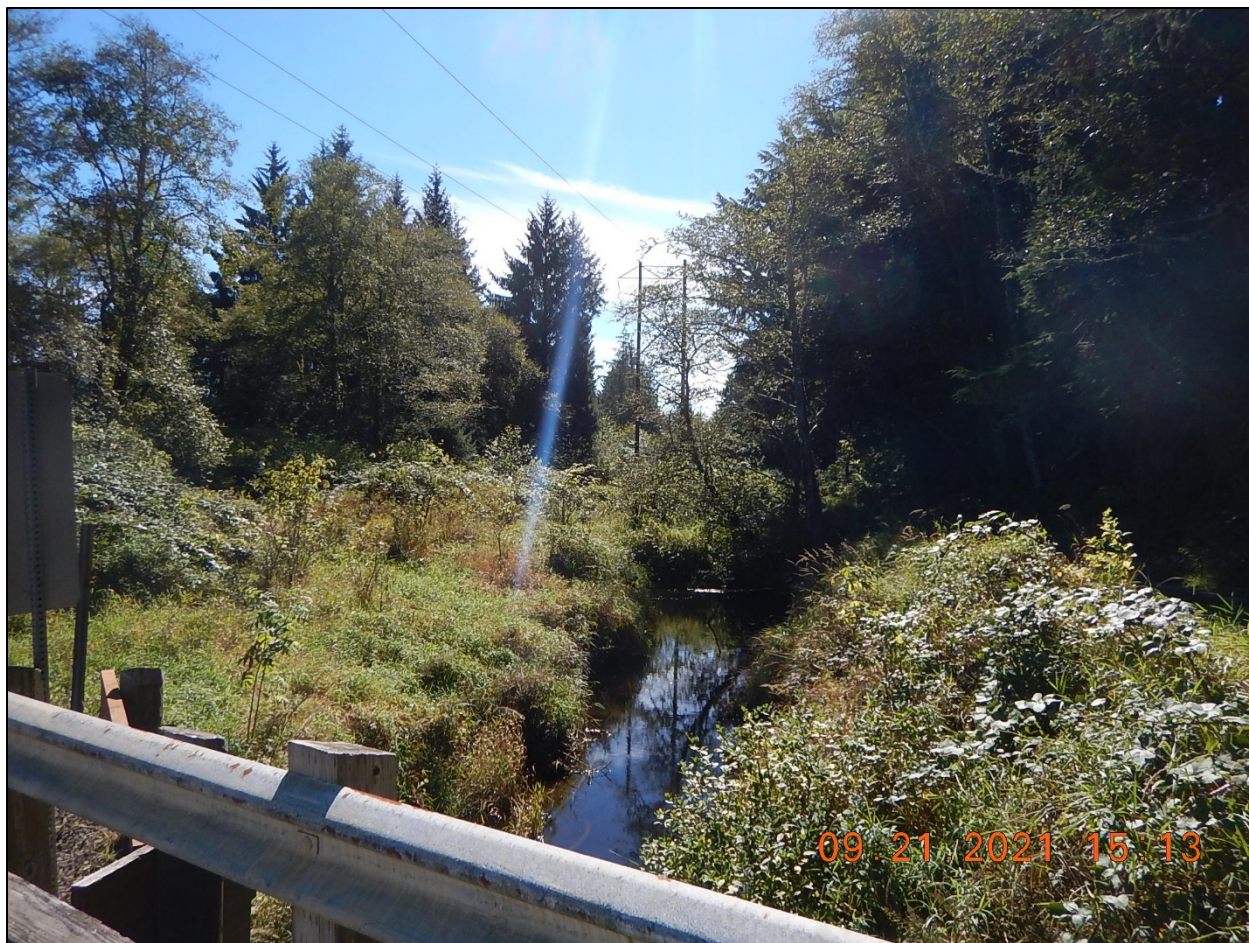
**Photograph 1.** View, facing southeast, of Circle Creek from approximately one mile northwest of the Jackson and Son Oil facility. This location is downstream from the facility.

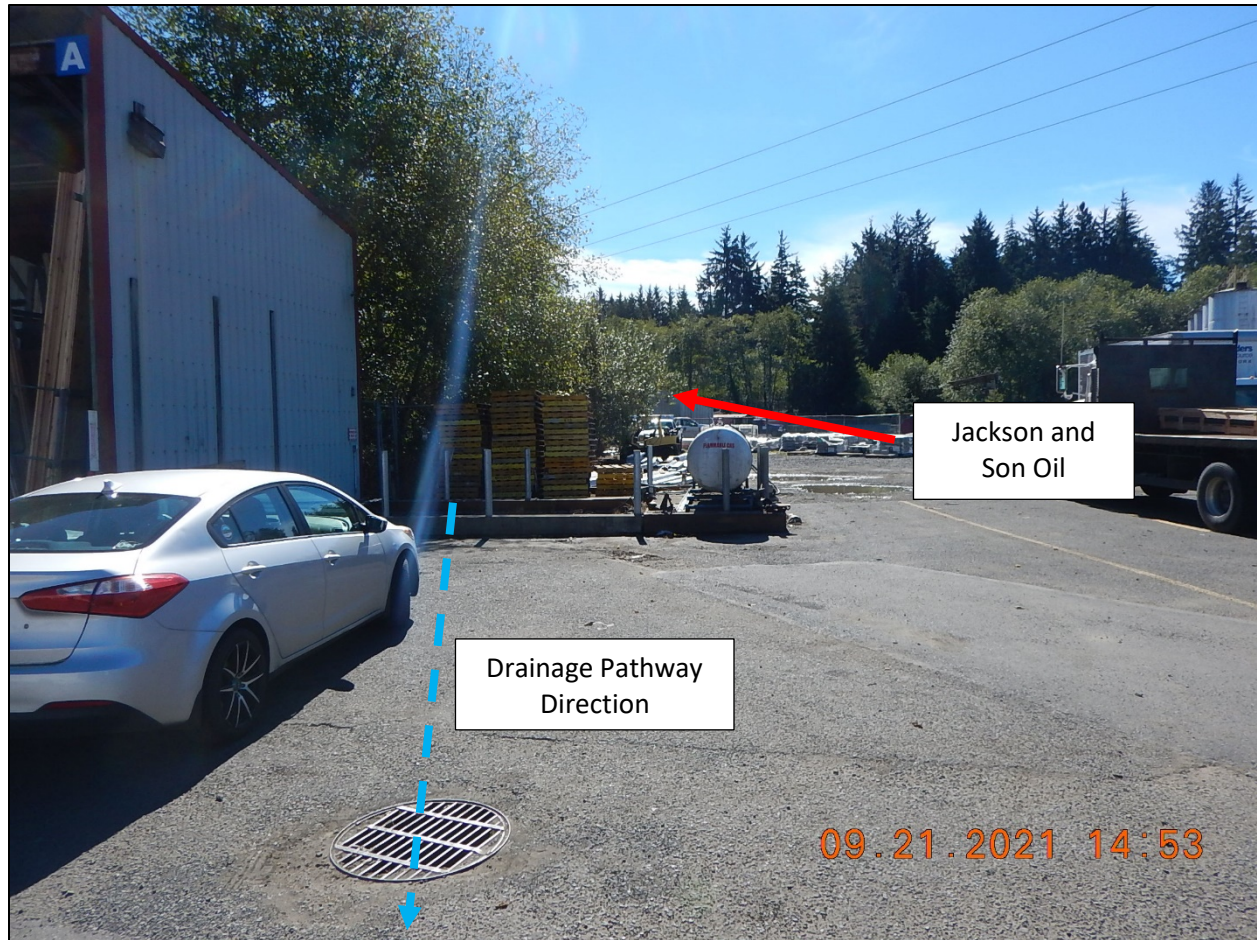
**Photograph 2.** View, facing southeast towards Jackson and Son Oil, of the drainage pathway from the northeastern portion of the Jackson and Son Oil facility. Note that the manhole inlet pictured is above the subsurface drainage conveyance running from the northeast side of the Jackson and Son Oil facility under the lumber yard to a wetland area located north of the lumber yard.

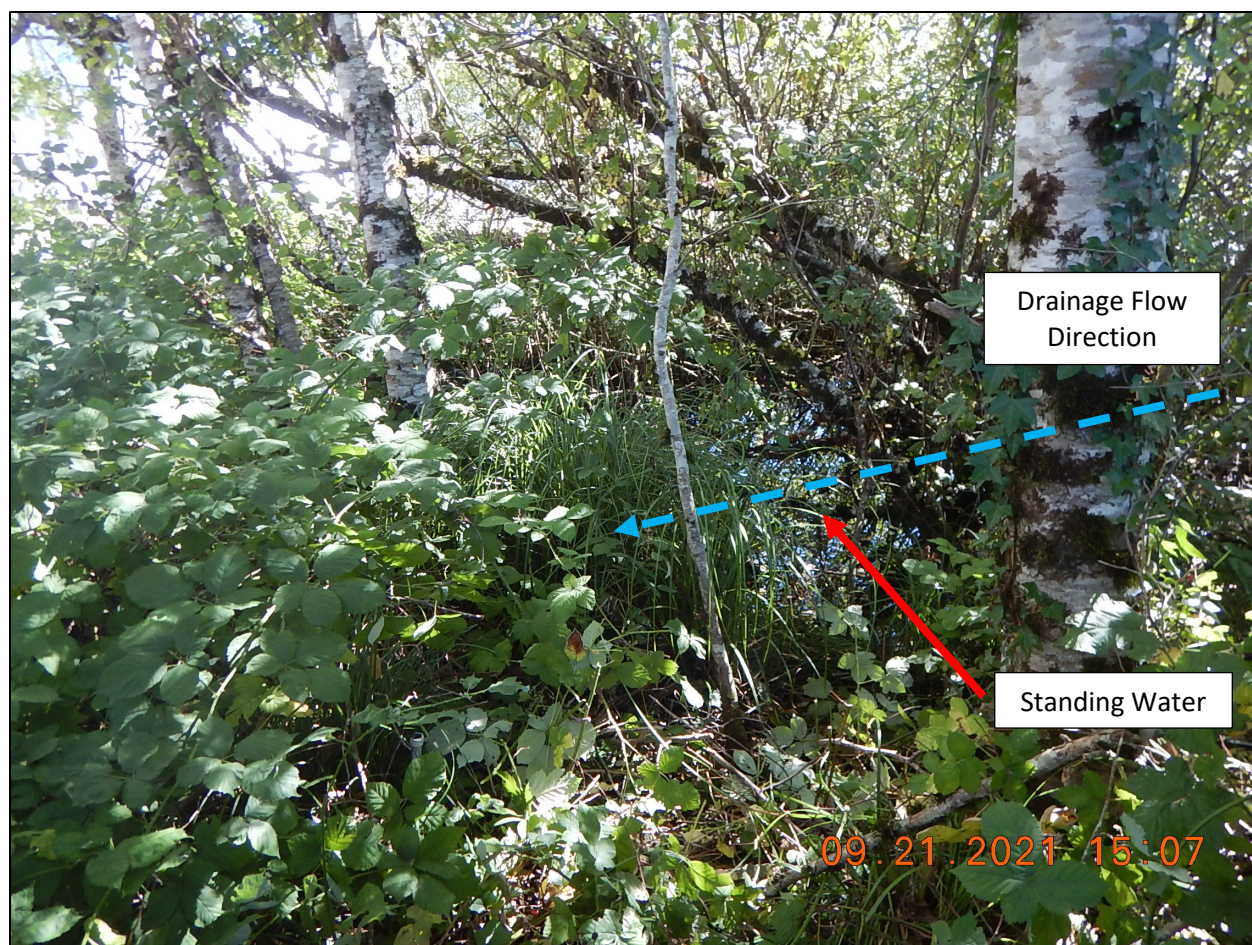
**Photograph 3.** View of standing water and the drainage direction from the northeast side of the Jackson and Son Oil facility before being conveyed underneath the lumber yard facility to the north.

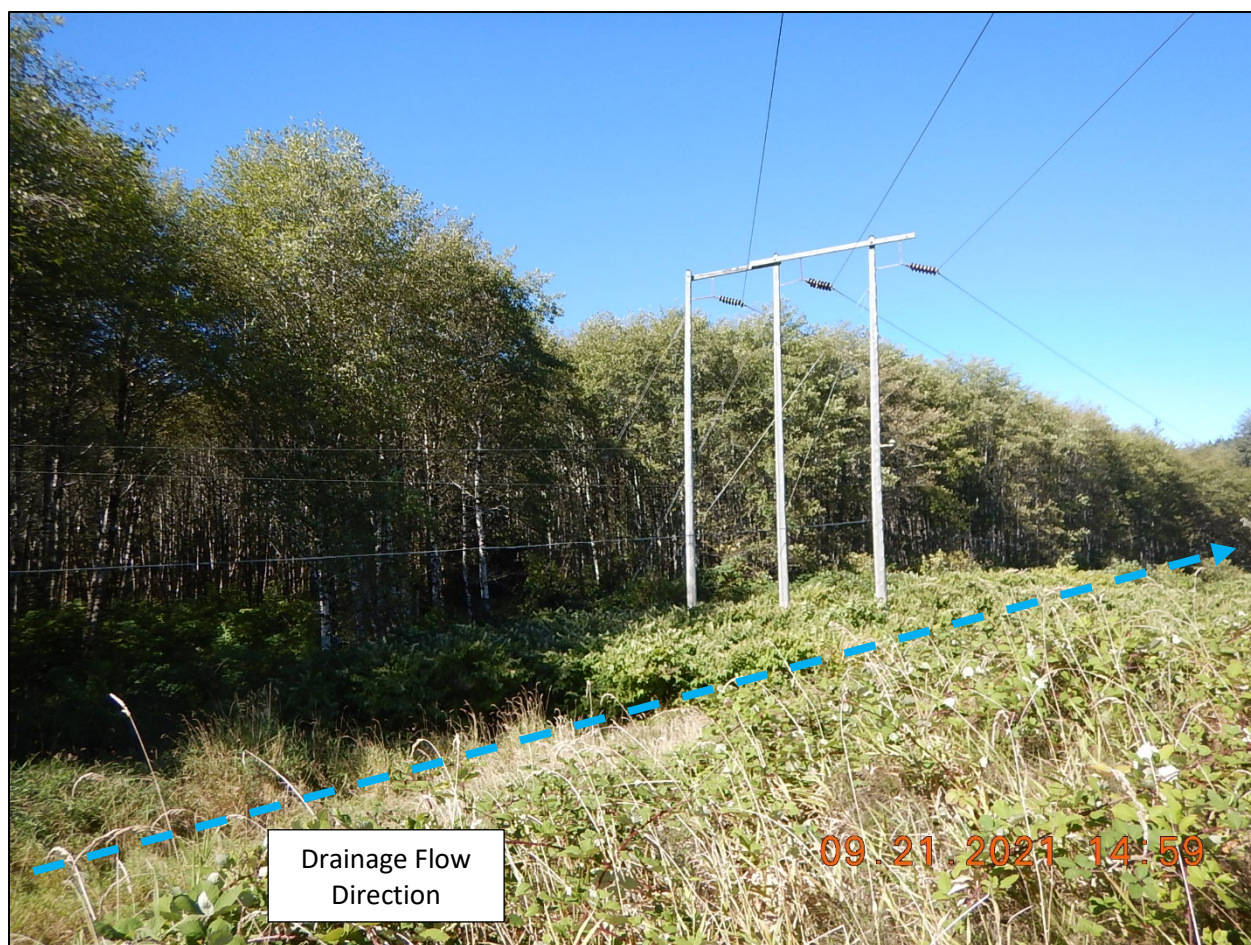
**Photograph 4.** View, facing northwest, of an apparent conveyance channel with powerlines running between Circle Creek and the wetland area north of the lumber yard.

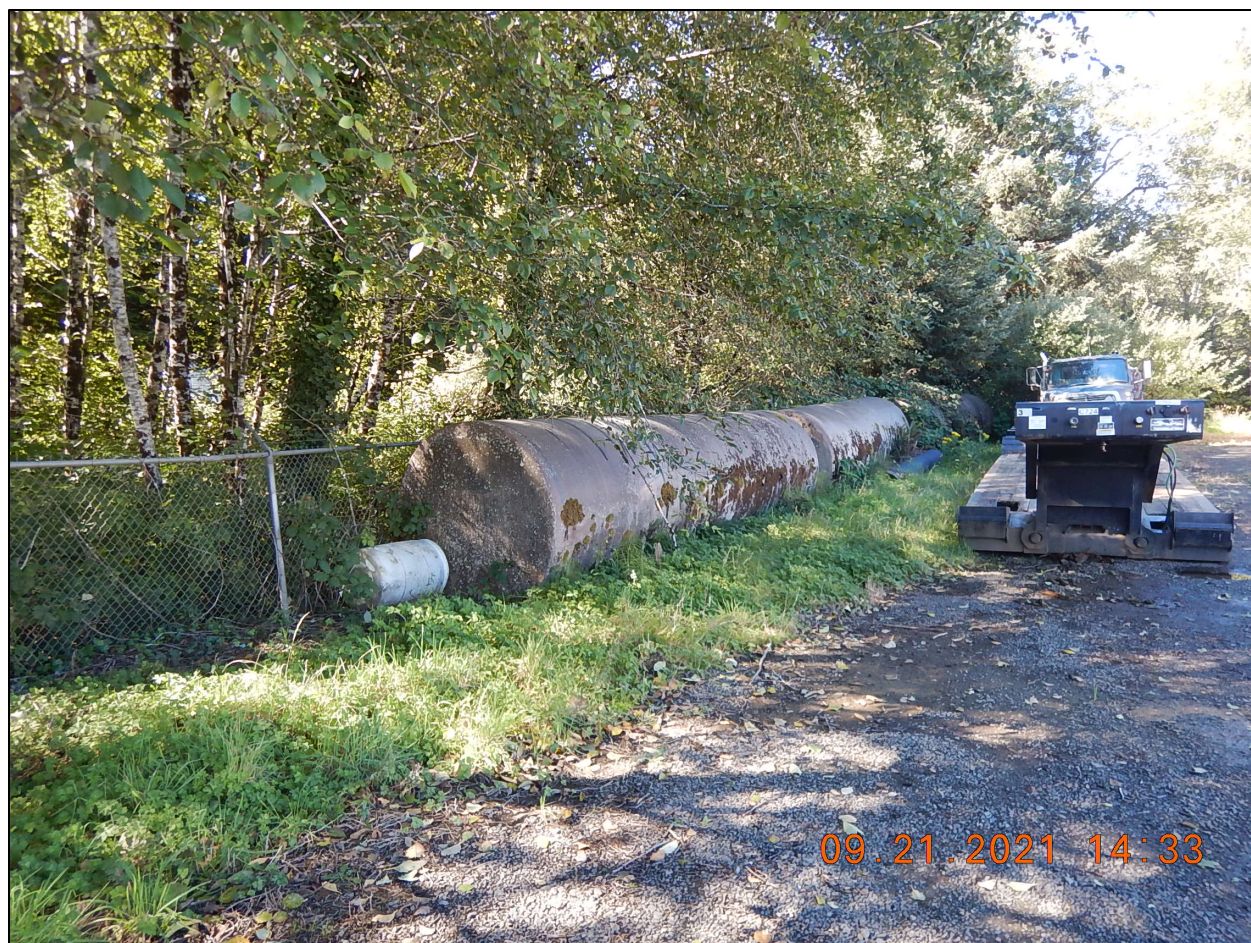
**Photograph 5.** View, facing west, of three large tanks located on the ground adjacent to the southwest perimeter of the facility. Facility representatives stated that the tanks were out of service, but the tanks lacked any labelling indicating they were permanently closed.

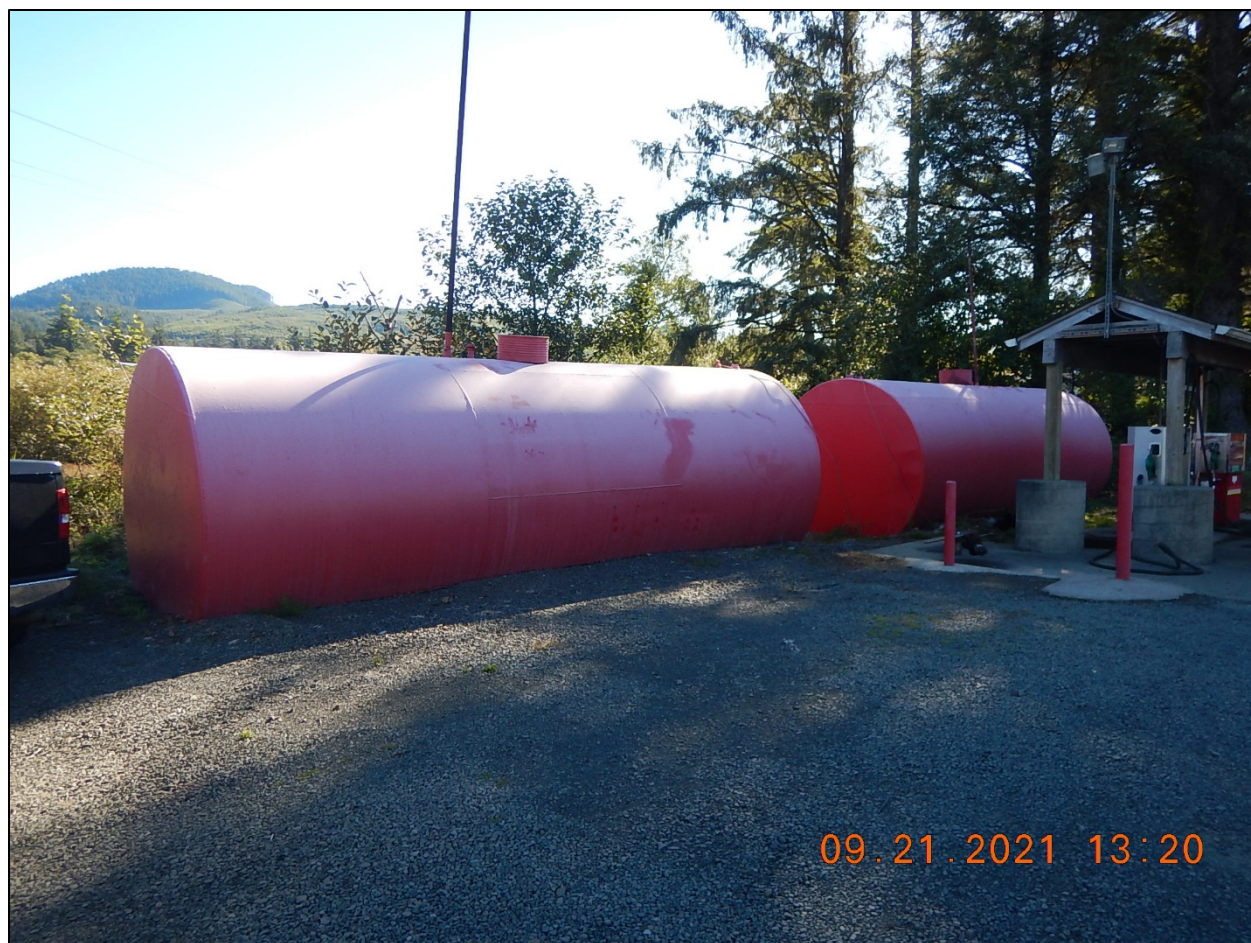
**Photograph 6.** View, facing east, of two 10,000-gallon single-walled diesel tanks without appropriate secondary containment. Note the location of the tanks in reference to the gravel parking lot.

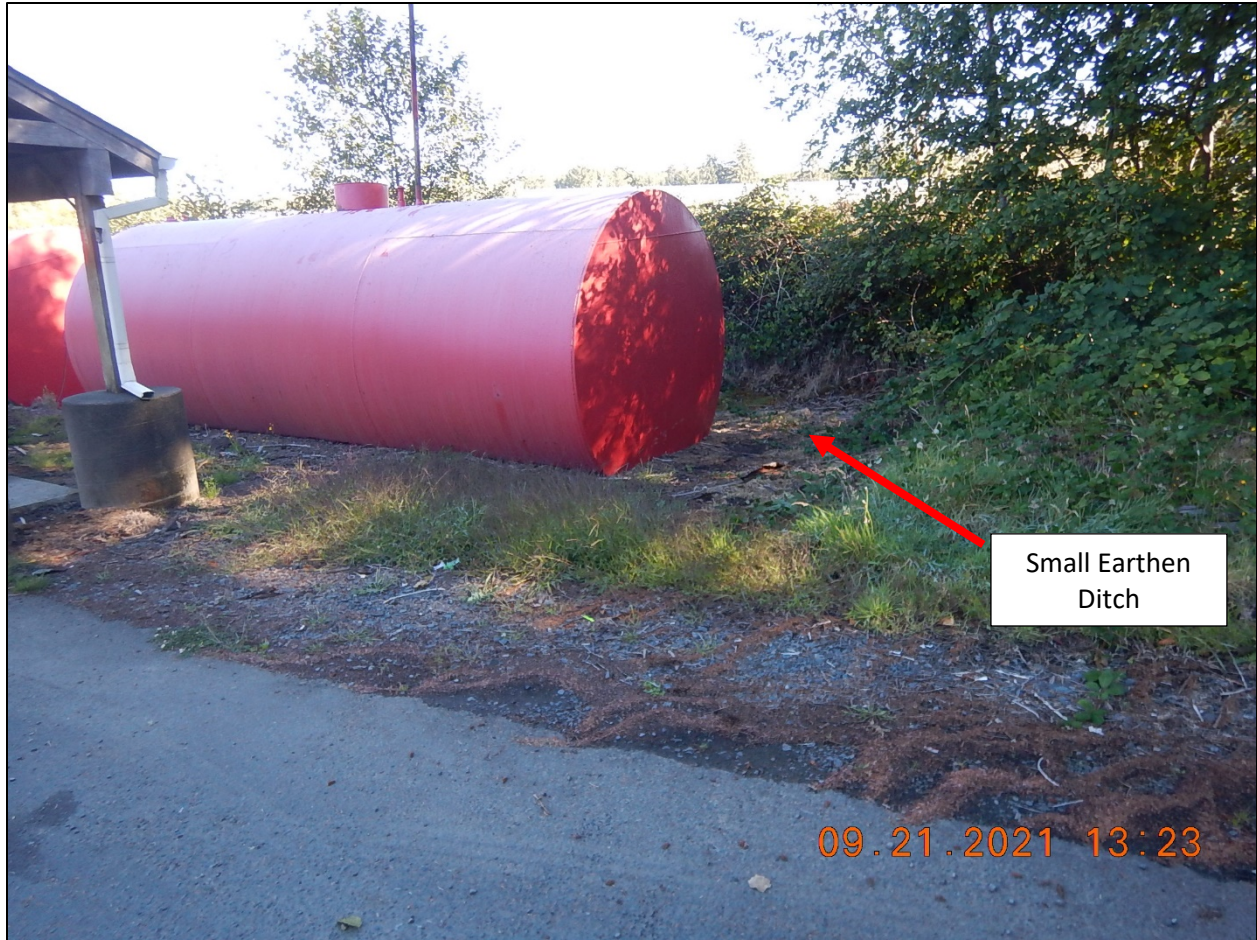
**Photograph 7.** View, facing northeast, of the two 10,000-gallon single-walled diesel tanks without appropriate secondary containment. Note the small earthen ditch located behind the tanks that facility representatives considered secondary containment. behind the tanks is almost at level with the paved parking lot. Also note that the small earthen ditch was nearly at-grade with the paved parking lot shown in this phorograph.

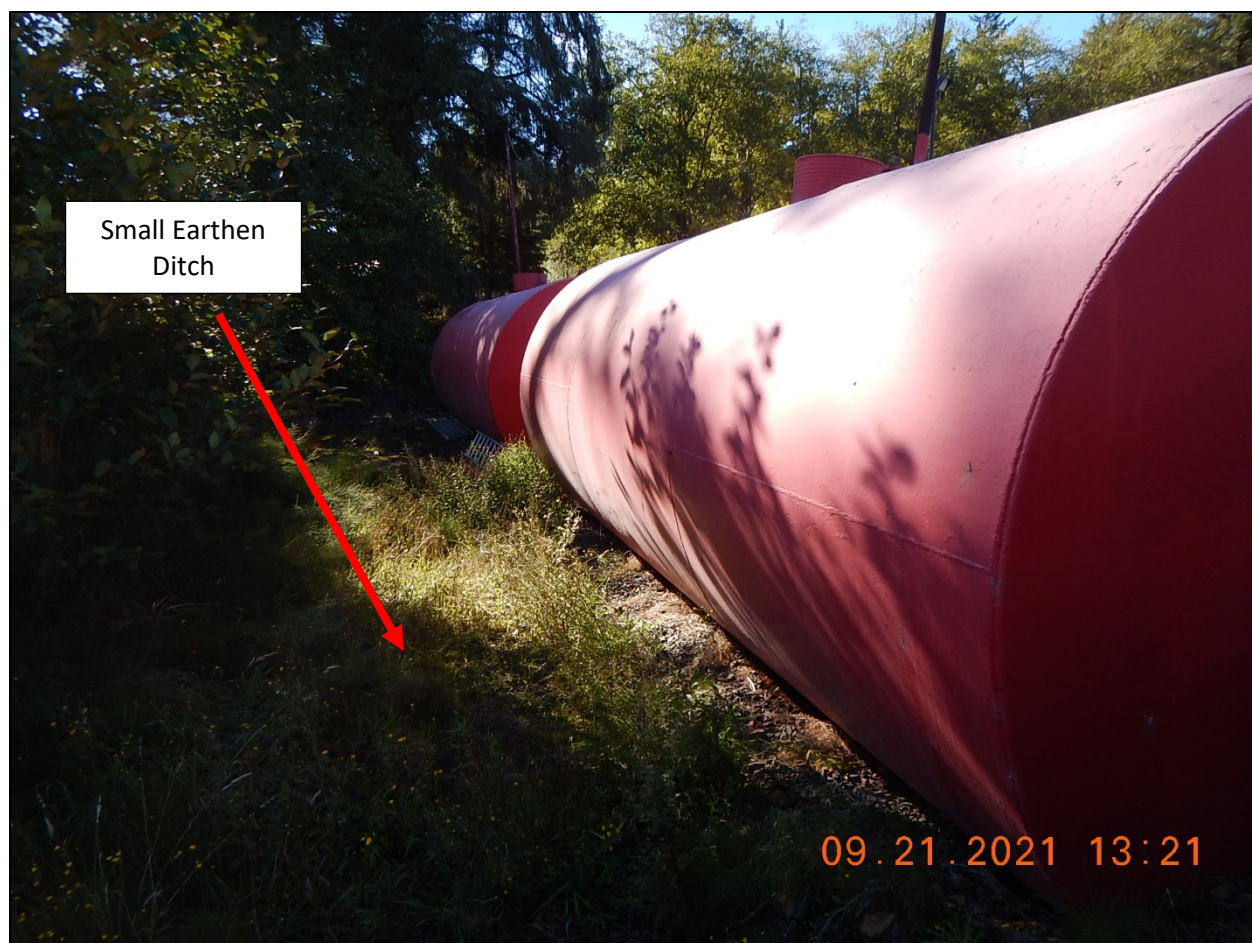
**Photograph 8.** View, facing southeast, behind the two 10,000-gallon single-walled diesel tanks without appropriate secondary containment. Note the dense vegetation in the small earthen ditch that facility representatives considered secondary containment. The diesel tanks were also observed lacking proper stabilization to prevent them from rolling back into the small earthen ditch.

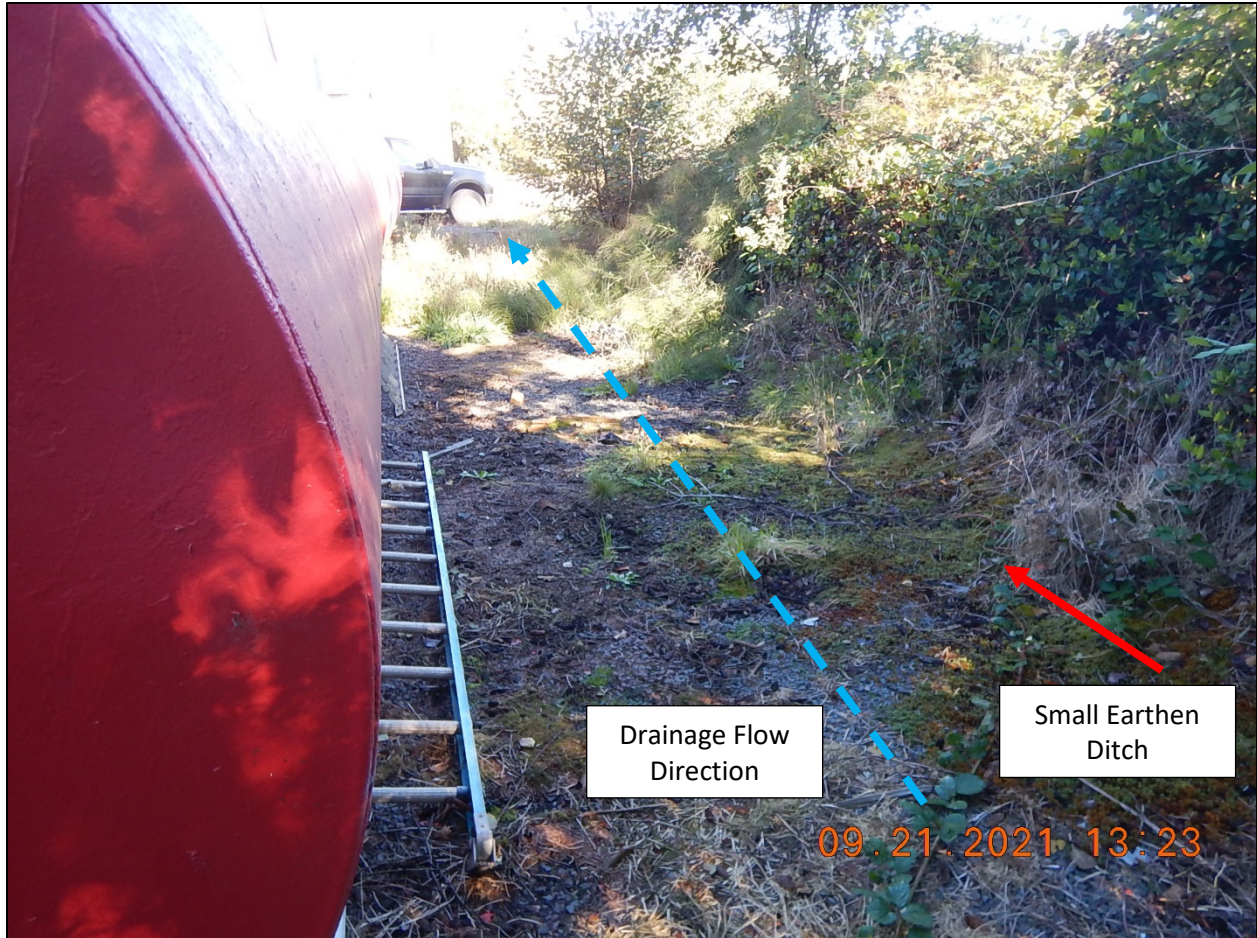
**Photograph 9.** View, facing northeast, behind the two 10,000-gallon single-walled diesel tanks without appropriate secondary containment. The area shown is the small earthen ditch that the facility representatives considered secondary containment for these two tanks. Facility representatives also stated that there is no liner under the tanks or ditch. Additionally, the east drainage pathway from the facility leading north under the adjacent Lumber Yard is located directly beyond this ditch.

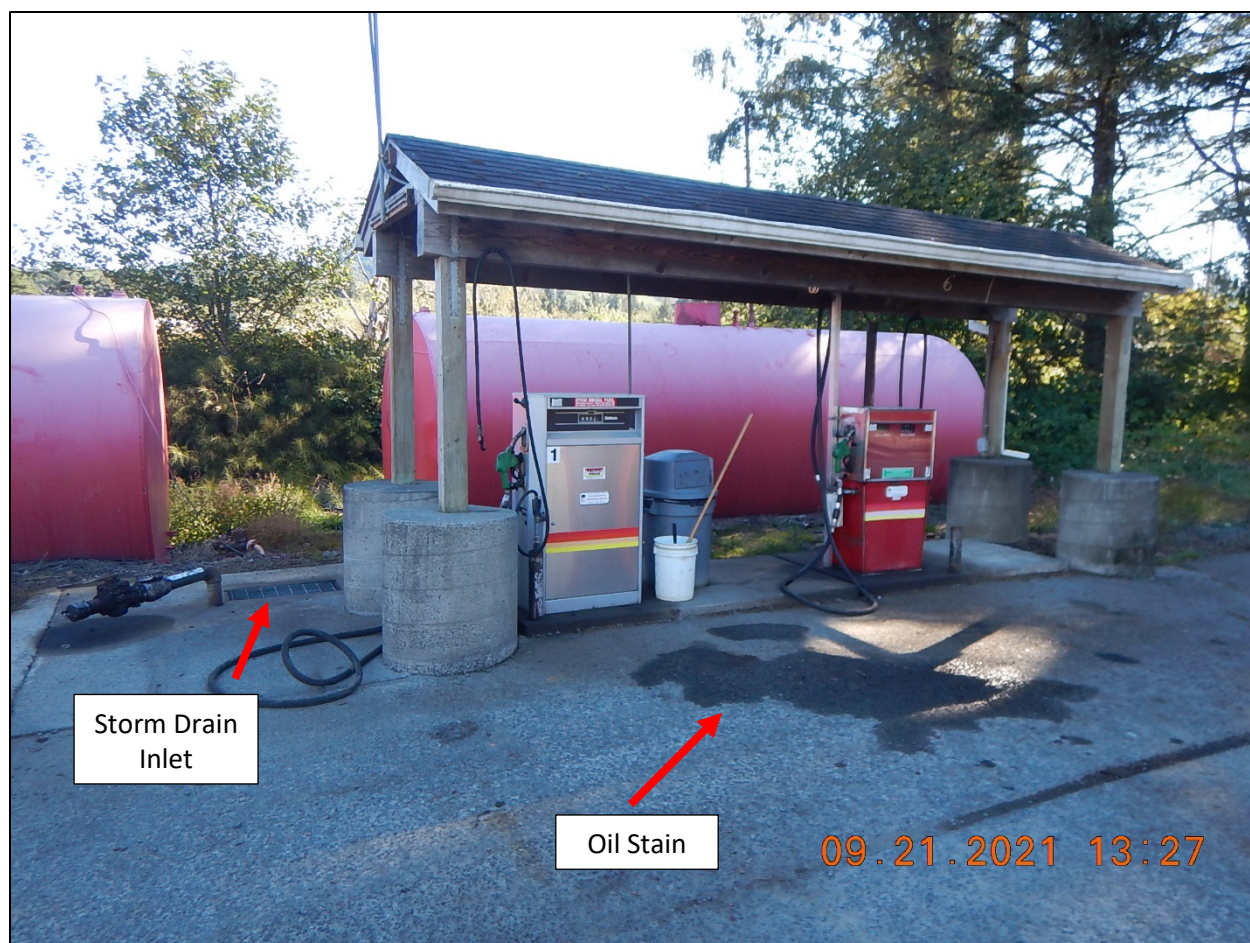
**Photograph 10.** View, facing east, of the facility's eastern diesel transfer area with a single storm drain inlet. Facility representatives stated this storm drain discharges to the small earthen ditch described in Observation #3 and Photographs 6 through 9. Also note the oil stain on the impervious surface at the transfer area.

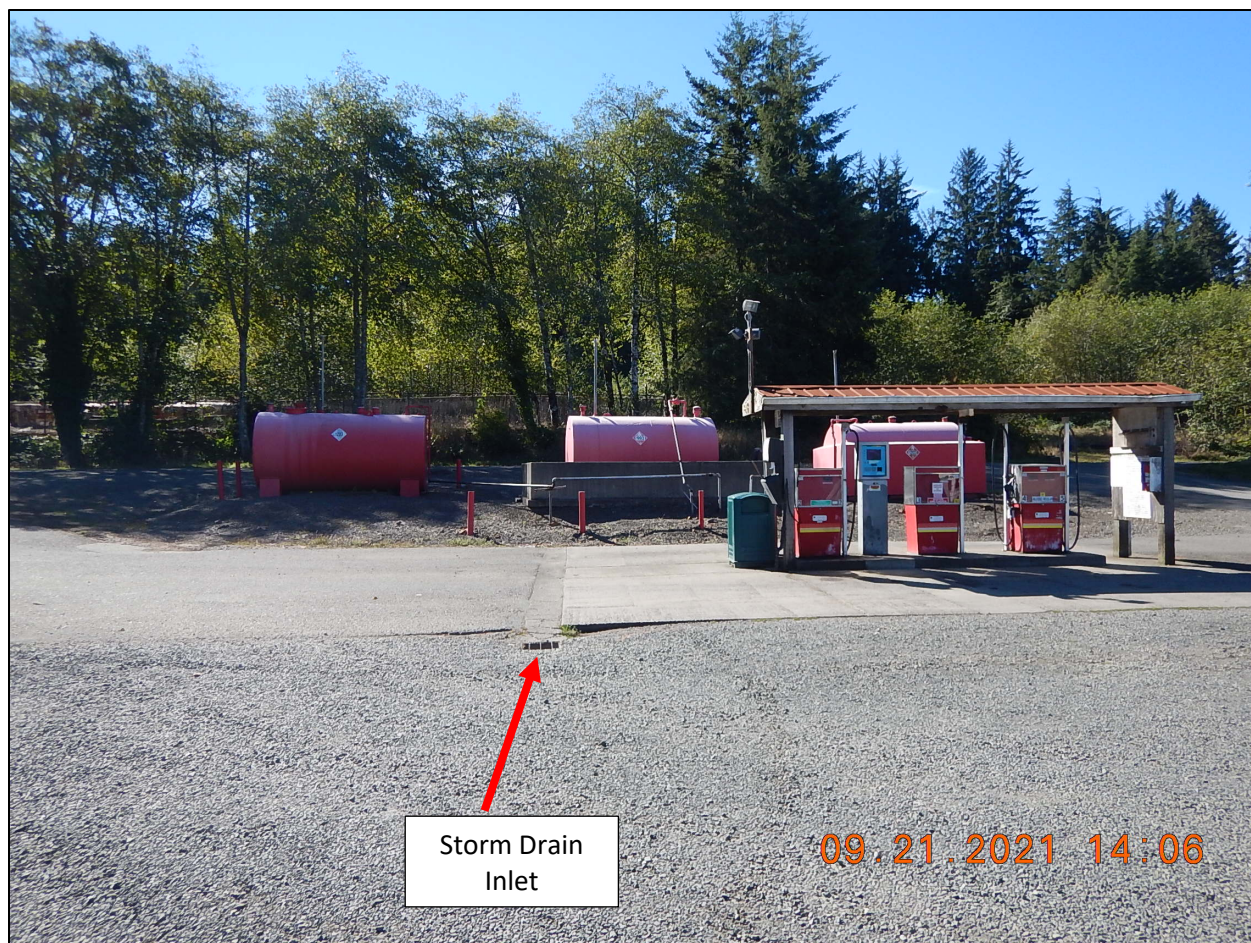
**Photograph 11.** View, facing south, of the facility's southern diesel and gasoline transfer area and one of the two storm drains located in this area. Facility representatives stated this storm drain discharges offsite, in the area of the northeast drainage pathway from the facility (refer to Photograph 13).

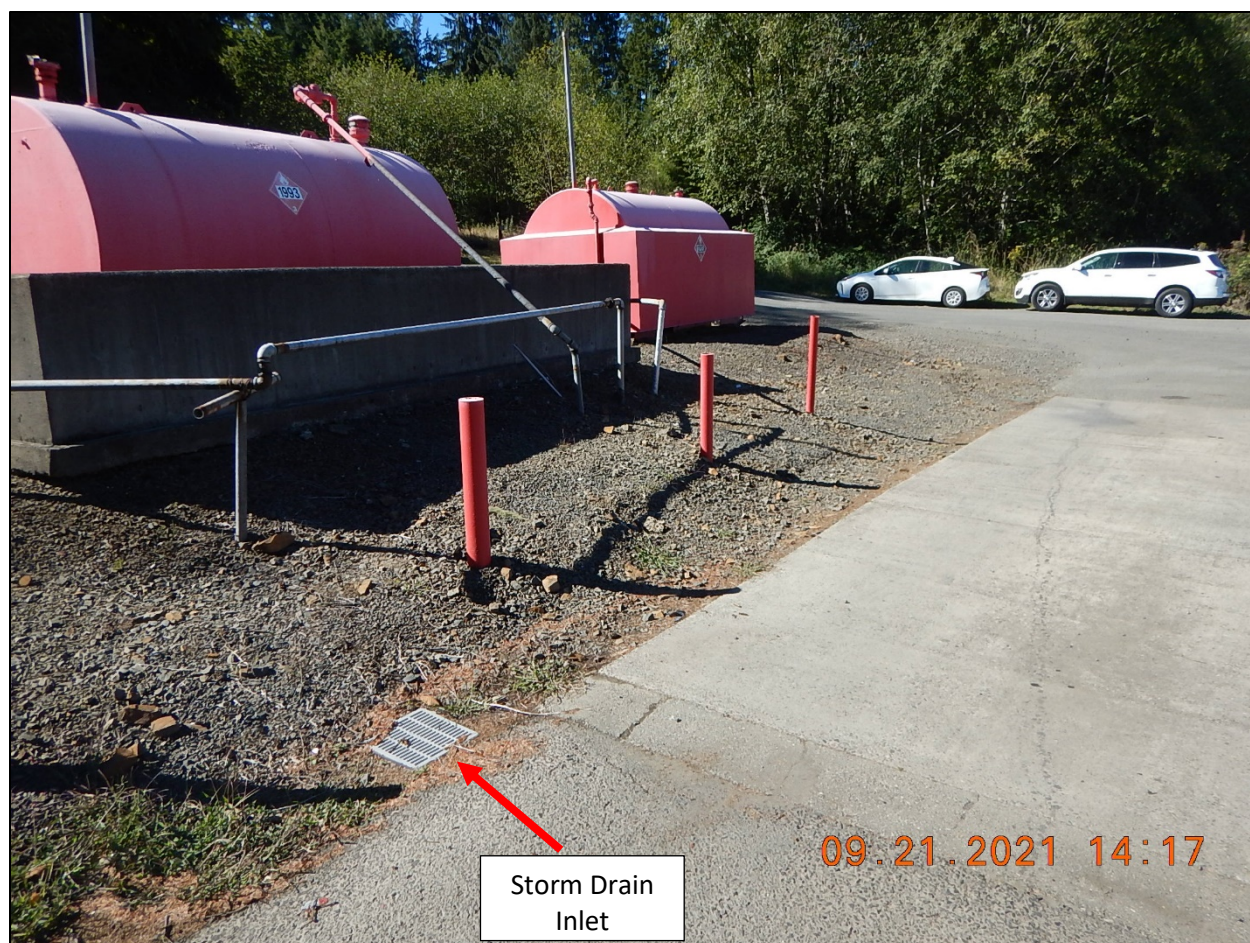
**Photograph 12.** View, facing southwest, of the facility's southern diesel and gasoline transfer area and the second of the two storm drains located in this area. Facility representatives stated this storm drain discharges offsite, in the area of the east drainage path from the facility (refer to Photograph 13).

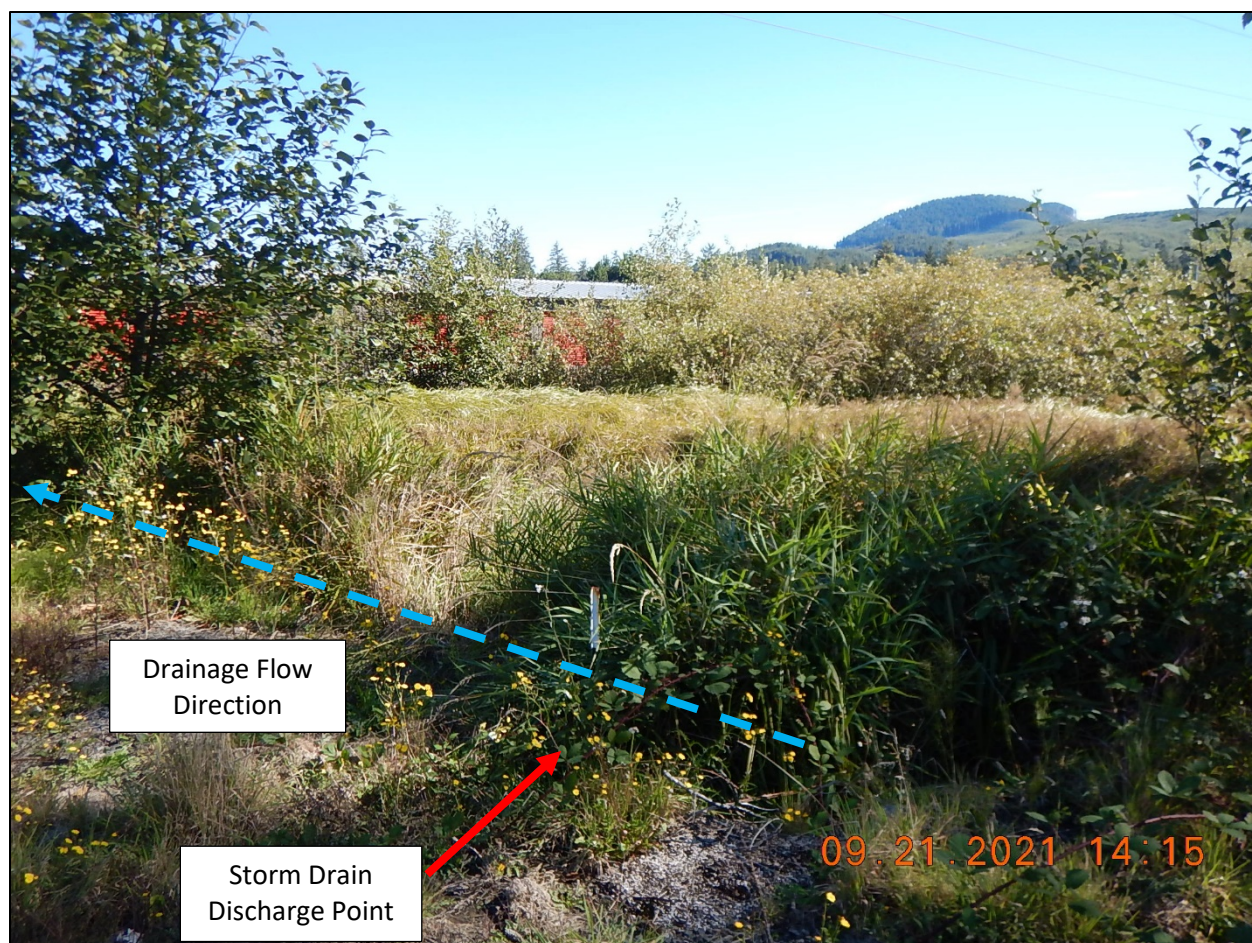
**Photograph 13.** View, facing northeast, of discharge point for the two storm drains located at the facility's southern diesel and gasoline transfer area. Drainage from this area of the facility flows north, under the adjacent Lumber Yard property, and into the wetland area north of the Lumber Yard.

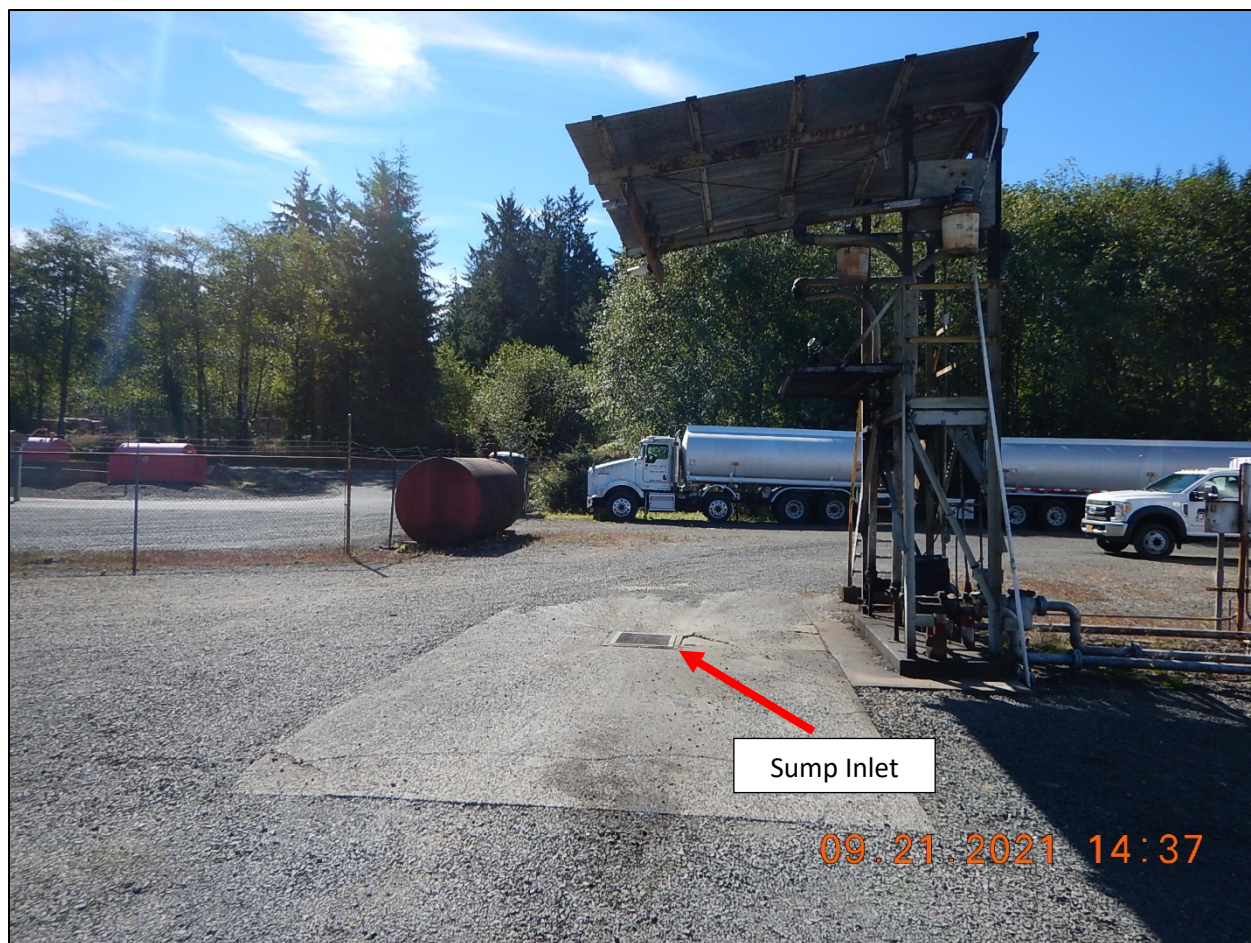
**Photograph 14.** View, facing south, of the facility's truck loading rack. Note the single sump inlet that is connected to a 100-gallon sump.

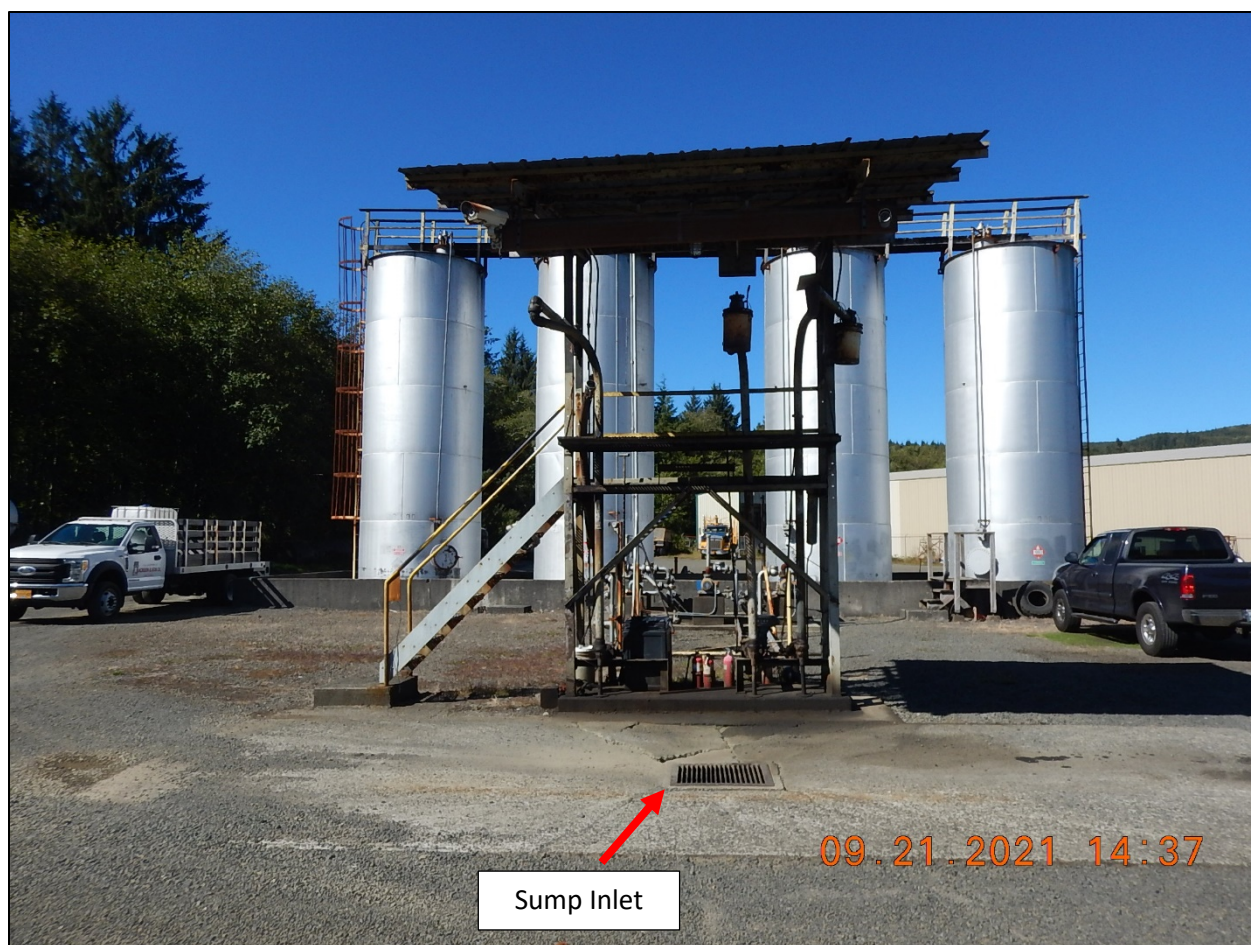
**Photograph 15.** View, facing west, of the facility's truck loading rack. Note the single sump inlet that is connected to a 100-gallon sump. Also note the lack of a brake interlock system, physical barriers, warning signs, or wheel chocks at the loading rack.

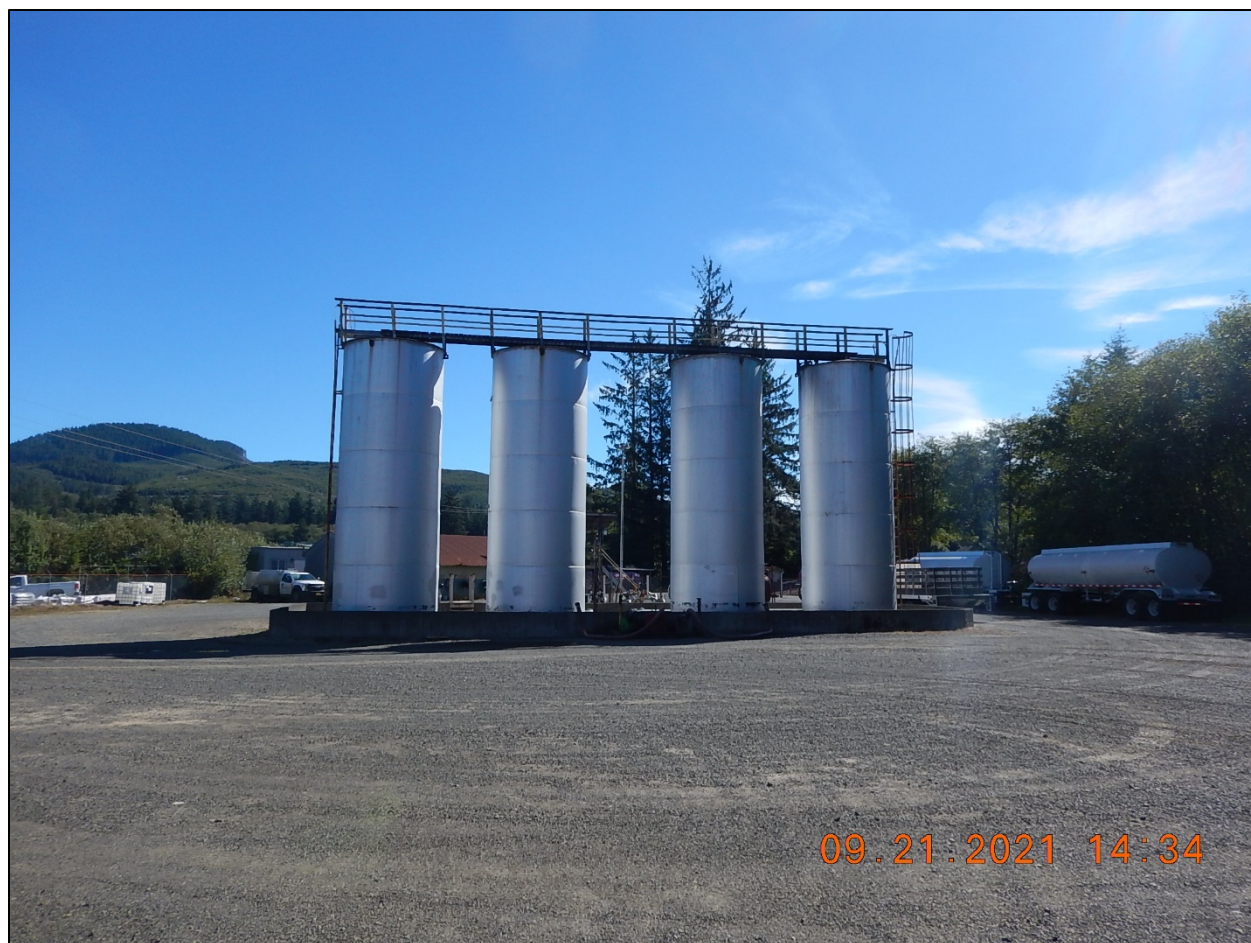
**Photograph 16.** View, facing east, of the four largest aboveground storage tanks at the facility located inside secondary containment.

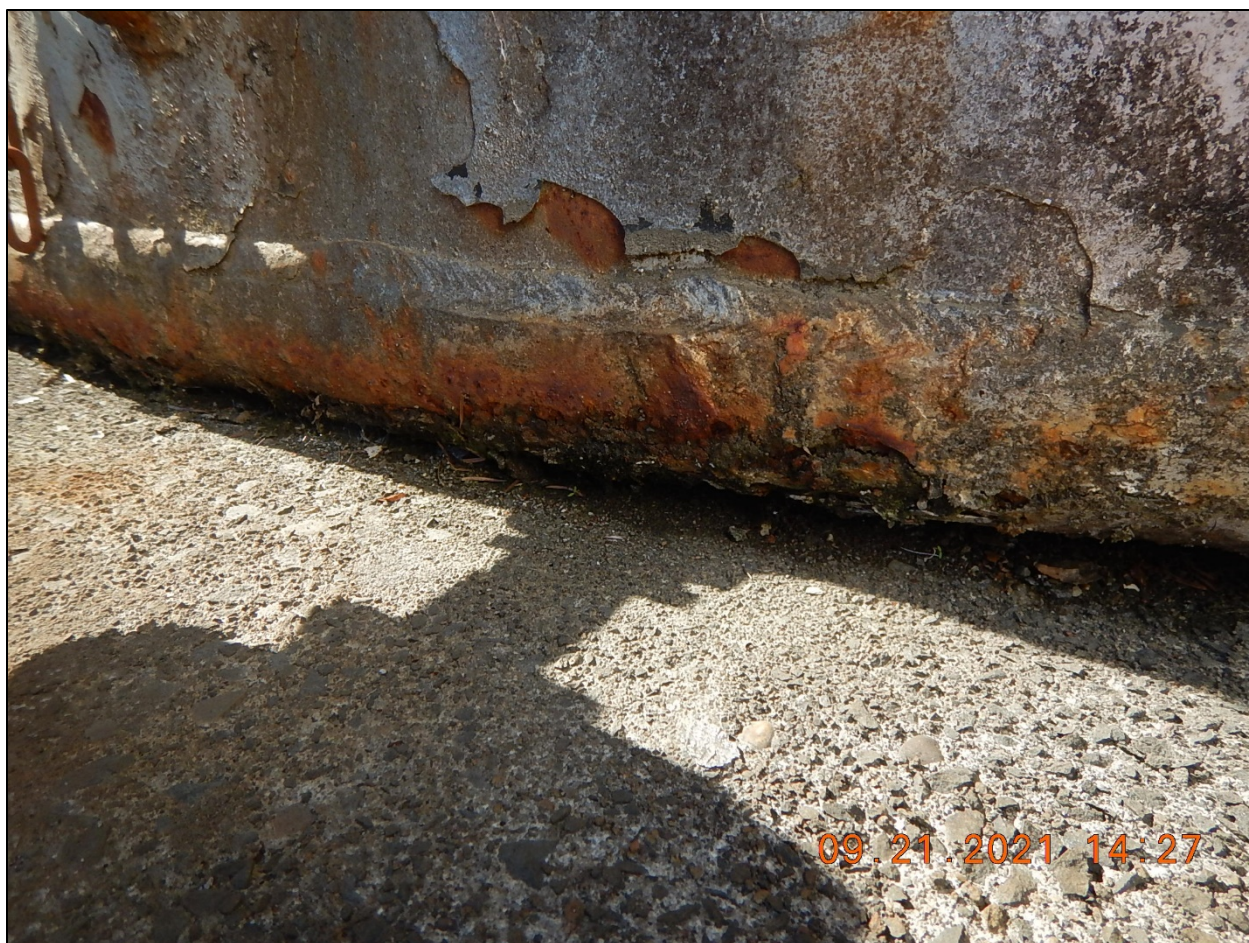
**Photograph 17.** Close up view of metal corrosion and delamination along the base of the rightmost tank shown in Photograph 16. Note that these tanks had never received any formal integrity testing since being placed into service.

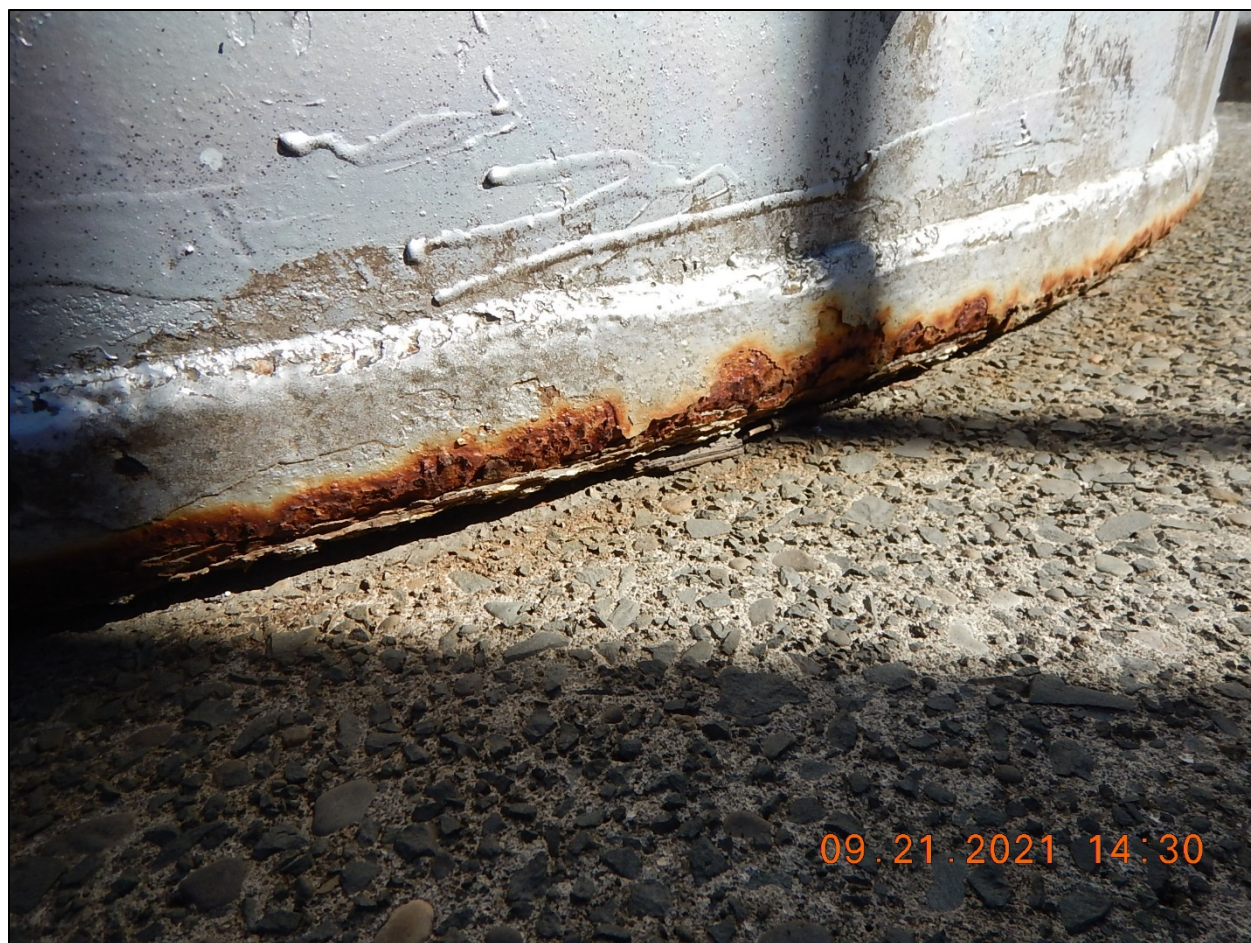
**Photograph 18.** Additional view of metal corrosion and delamination along the base of the second from the rightmost tank shown in Photograph 16. Note that these tanks had never received any formal integrity testing since being placed into service.
